# The NAMS Global eNews

March, 2021

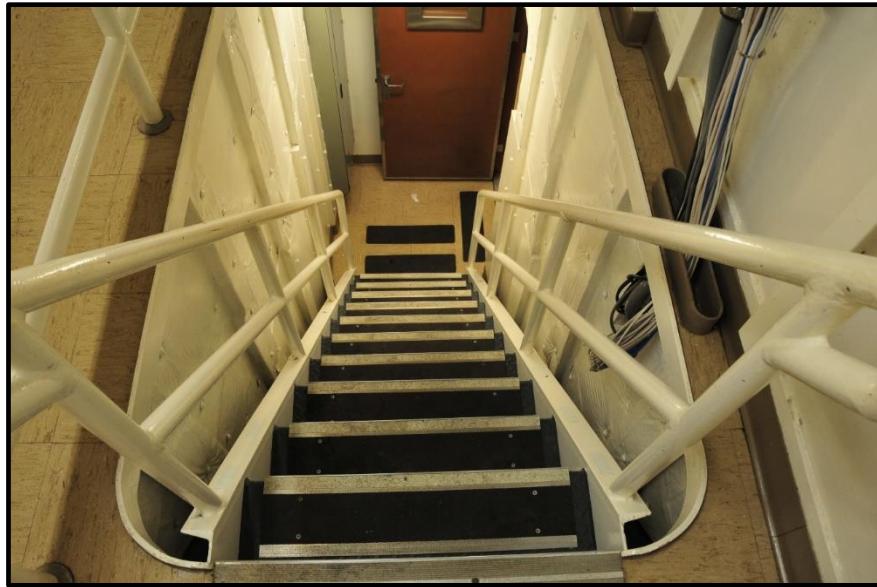
QUESTION: Below is a picture of a type of passageway connecting two decks sometimes found on larger uninspected commercial vessels. You measure its inclination at 55°. How would you describe it in your report? Is it safe?

ANSWER: At  $55^\circ$  of inclination you are looking at what OSHA describes as "ship stairs" as seen in Figure D-10 below, taken from OSHA 29 CFR 1910 Subpart D *Walking Working Surfaces*.

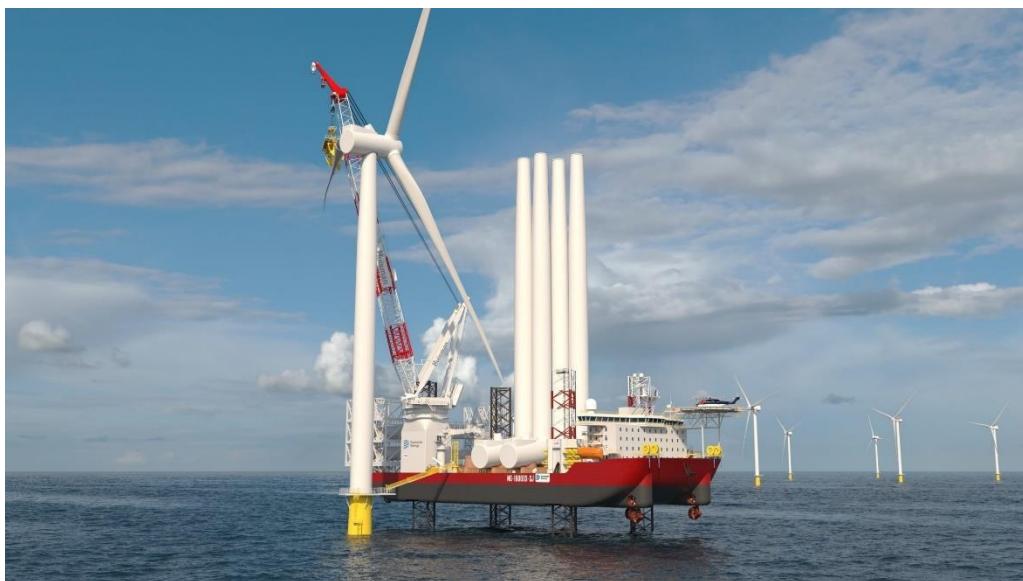
An illustration shows a planned Jones Act-compliant offshore wind installation vessel under construction for Dominion Energy.

We just learned that the newbuild vessel currently under construction at the Keppel AmFELS shipyard in Brownsville, Texas for Dominion Energy will be built to ABS class . The 472-foot vessel is designed by GustoMSC to handle turbines of 12 megawatt or greater. It will also be capable of the installation of foundations for turbines and other heavy lifts.
