Thermal Imagers and Marine Inspections

By Charles J. Hazouri,

Offshore Marine Inspections

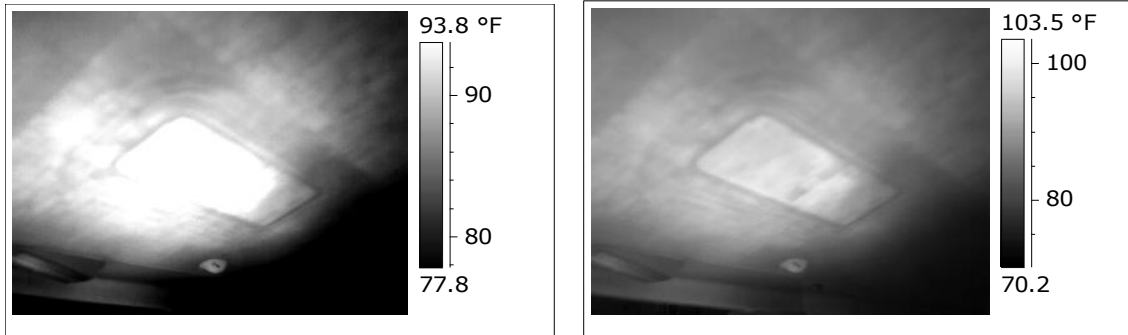
The image on the left is an example of an image from the T440BX that has not been thermally tuned using the computer's software. As you can see, there are numerous areas of reduced contrast, distortion, and some areas that could be mistaken for anomalies, unlike the image on the right, which has been thermally tuned.

The stand-alone thermal imagers described above were capable of being thermally-tuned using the FLIR Tools + software on a desktop or laptop computer. The FLIR One was only capable of being tuned by using the FLIR tools application on the iOS 9.2.1 iPhone and aftermarket software. Thermally tuning an image allows you to manually adjust the temperature level or span, which is the equivalent to a brightness and contrast adjustment. Thermal tuning can be done on the imager in manual mode or in the software to reduce wash out.

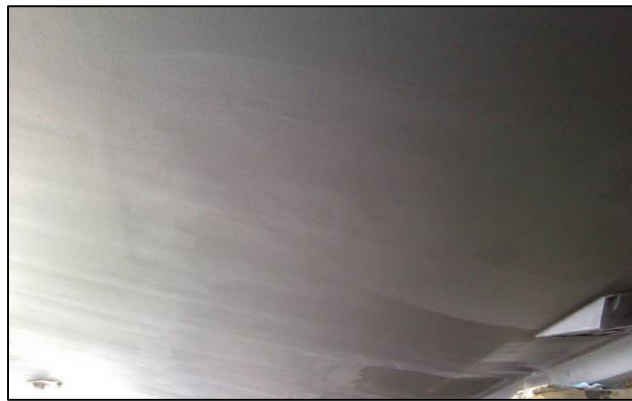
Looking Forward

Infrared Test Results: The following four, grey scale thermal images were taken of a recent repair to the hull of an 80' Viking Sport Fisherman. These images will demonstrate the different quality of images obtained by using a higher hertz and resolution imager in comparison to an imager with lower hertz and resolution.

FLIR T440BX

As you can see, the above images show that the T440BX gives you the definition and delineated edges needed for proper inspection. The T440BX actually shows the layers of tabbing for the fiberglass insert, indicated by the black arrows in the images above.

The C2 and FLIR One are too distorted and do not show enough detail and information to do a proper laminate inspection. The FLIR One image could not be thermally tuned using the recommended software in a computer but could be tuned using aftermarket software and the iOS 9.2.1 application. Having an image with specific detail is important for a contractor or boat owner. It documents that repairs are correct and precise.

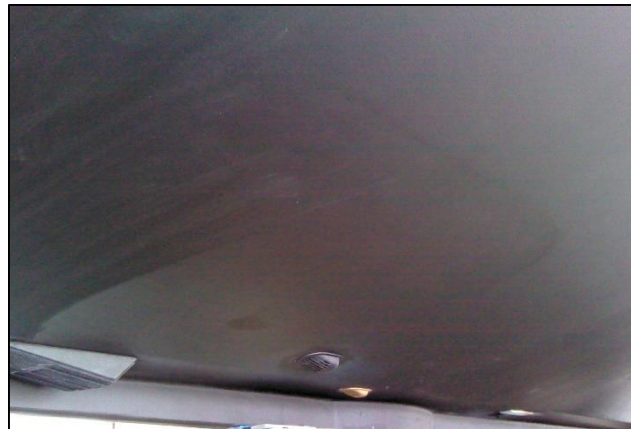
Looking Aft

FLIR T440BX

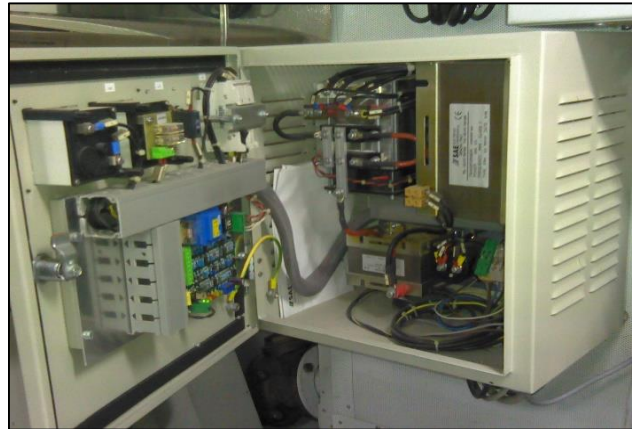
FLIR T440BX

The following two, iron scale thermal images taken of a normal operating battery charger imaged with Multi Spectral Dynamic Imaging or MSX[®]. MSX[®] adds key details from the visible light camera to the entire thermal infrared image^v. This shows which imager gives enough visual information to do a proper inspection. MSX[®] does require that you have good visible light for the imager unless you can thermally tune the image using the proper computer software.

As you can see in these images, the T440BX gives you definition and delineated edges for the electrical inspection. The FLIR One image was slightly distorted. A clearer image is necessary when using MSX[®] so the inspector can identify the problem area with enough detail to provide useful advice and/or information.

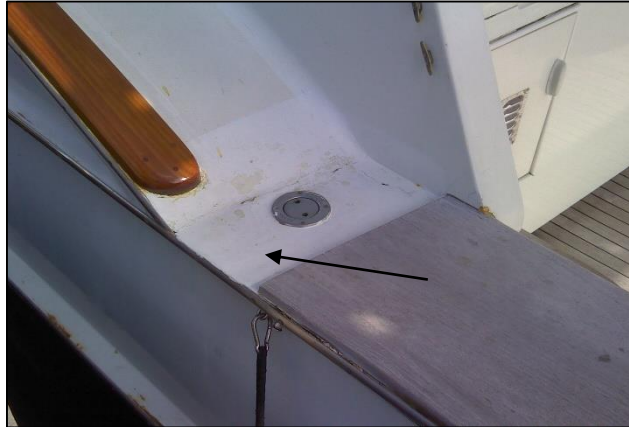
FLIR T440BX

The following eight, iron scale thermal images taken of the port side deck fuel fill and cockpit bulwarks of a 72' Blackwell Boatworks Sport Fisherman will outline and demonstrate which imager is best for moisture ingress and/or water intrusion in fiberglass laminates.

As you can see, the T440BX give you the definition and delineated edges for the inspection. With the Spot1 (Sp1) and Sp2 temperature readings, the T440BX and E6 show close to a ten degree Fahrenheit temperature difference, while the C2 showed just under a six degree temperature difference. The E6 is slightly distorted while the C2 and FLIR One are quite distorted and do not show what you need to do a proper inspection by defining the actual area of concern as indicated by the black and white arrows. An actual Delta T could not be determined in the FLIR One image.

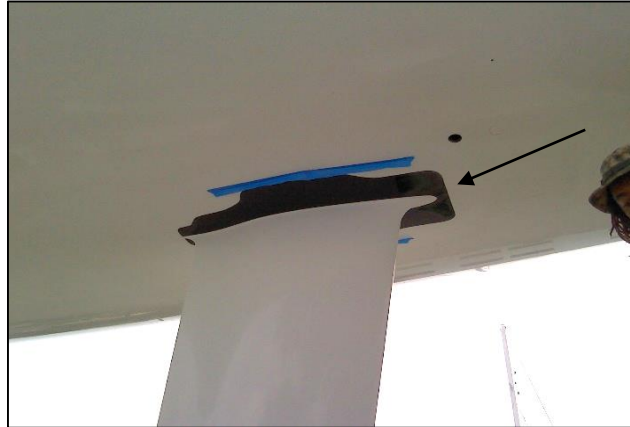
FLIR T440BX

The following two, grey scale thermal images taken of the carbon fibre keel flange of a 52' Transpac TP52 Sailboat will outline and demonstrate which imager is best for vessels constructed of carbon fibre.

The above images show that the T440BX gives you the definition and delineated edges for good inspection. The C2 is distorted and does not show what you need to do a proper inspection.
